Retention of Sputtered Molybdenum on Ion Engine Discharge Chamber Surfaces

James S. Sovey, Joyce A. Dever, and John L. Power
Glenn Research Center, Cleveland, Ohio

Prepared for the
27th International Electric Propulsion Conference
cosponsored by the AFRL, CNES, ERPS, GRC, JPL, MSFC, and NASA
Pasadena, California, October 14–19, 2001

1. AGENCY USE ONLY (Leave blank)		2. REPORT DATE December 2001		3. REPORT TYPE AND DATES COVERED Technical Memorandum
4. TITLE AND SUBTITLE Retention of Sputtered Molybdenum on Ion Engine Discharge Chamber Surfaces			5. FUNDING NUMBERS WU-755-B4-04-00

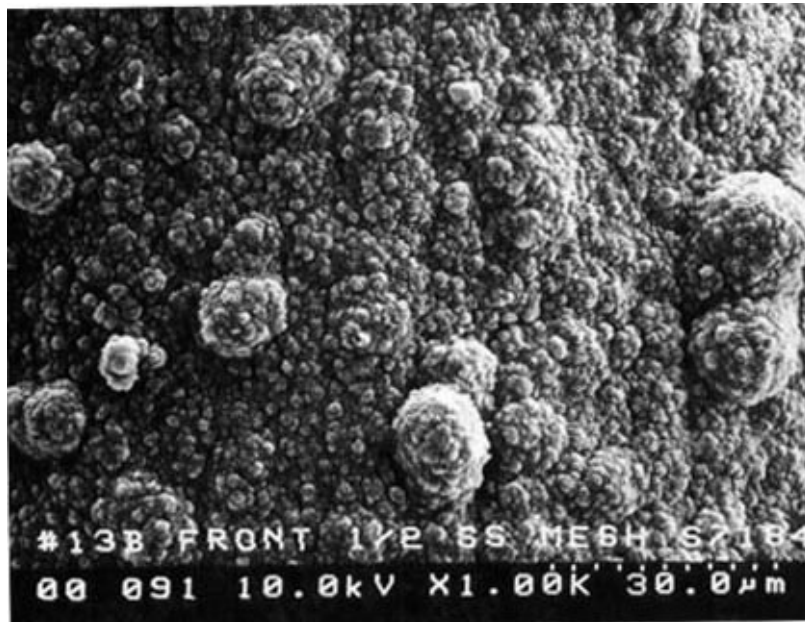
Figure 1a – Photomicrograph of the surface structure of a metal flake found in the discharge chamber of the 30 cm diameter ion engine that completed the 8200 hour Life Demonstration Test.
(Courtesy of the Jet Propulsion Laboratory)

of this ion engine was one of the longest tests of an inert-gas ion engine and provided data on coatings and flaking within the discharge chamber. This test was run at full-power, 2.3 kW, and the engine had a xenon throughput of 88 kg. In this engineering model engine, the downstream 520 cm^2 of the discharge chamber anode was covered with grit-blasted wire-mesh. The upstream aluminum surfaces (1650 cm^2) were simply grit-blasted to retain the sputtered material. Post-test diagnostics [7] of the discharge chamber determined that a very adherent coating composed of molybdenum and stainless steel products was found on the grit-blasted wire mesh and aluminum surfaces (Table 1). The thickness of these adherent coatings ranged from 2 μm to 5 μm . Loose flakes were also found at the bottom of the discharge chamber. The thickness of these flakes was in the 2 μm to 12 μm range, and the composition was primarily molybdenum, stainless steel products, and tantalum. Molybdenum by far was the major constituent of flakes collected at any location in the discharge chamber. Figures 1a and 1b are scanning electron photomicrographs of the morphology of the surface and section-view of a

typical 12 μm thick flake. The material appears very granular and “lumpy”. The largest flake found in the cylindrical part of the chamber was 1.7 mm by 0.7 mm. In the vicinity of the cathode a 3.8 mm by 0.1 mm flake was found. All loose flakes that were analyzed had planar dimensions in the 100 μm to 3800 μm range. Since most of the wire mesh external surface is comprised of 51 μm diameter wires, it is clear that these flakes did not spall from the wire mesh surface. The source of the loose flakes may have been the cathode/keeper-electrode or other surfaces that were not grit-blasted or covered with wire mesh. Even though the ion extraction grid gap is about 0.66 mm, the loose flakes did not produce any permanent grid shorts.

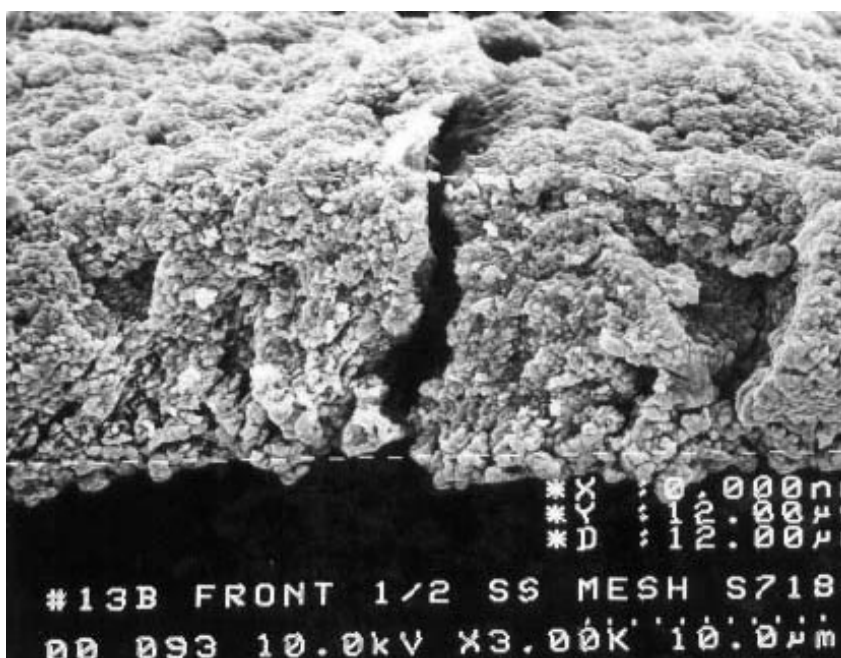
Figure 1b – Photomicrograph of the cross-section of a flake found in the discharge chamber of the 30-cm diameter ion engine that completed the 8200 hour Life Demonstration Test. Flake thickness is about 12 μm . (Courtesy of the Jet Propulsion Laboratory)

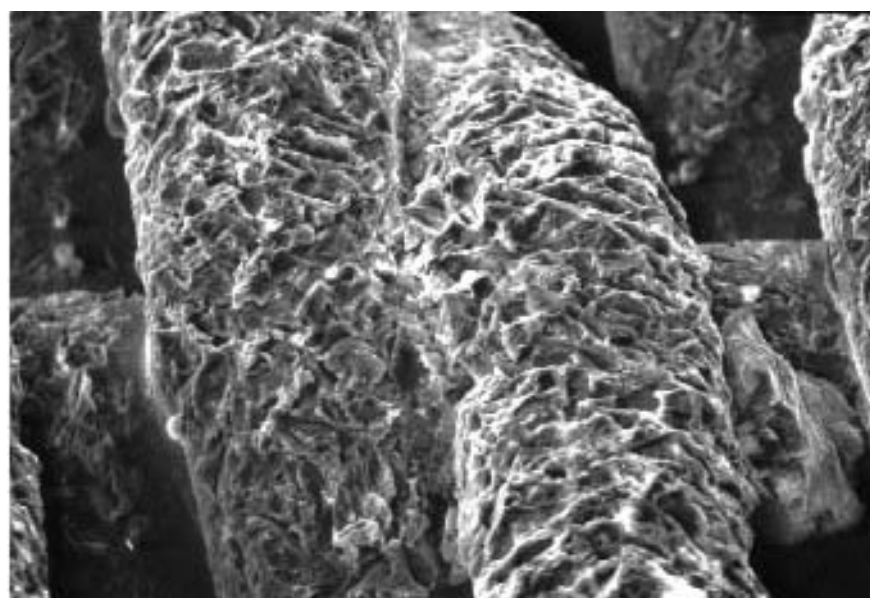
Figure 2 – Photomicrograph of grit-blasted wire mesh. The wire diameter is 51 μm .

Figure 5 shows the 51 μm diameter wires coated with 25 μm of molybdenum. The coatings exhibit a rough structure that is dictated by the grit-blasted substrate that is shown in Figure 2. Energy dispersive analysis using X-ray diagnostics verified the coating was pure molybdenum with trace amounts of chromium, zirconium, and possibly phosphorus. Figure 6 is a highly magnified photograph of the 51 μm diameter wire coated with 8 μm of molybdenum. This photograph indicates that the coating may be comprised of “macro-columns” whose cross-sections have dimensions in the 6 μm to 17 μm range.

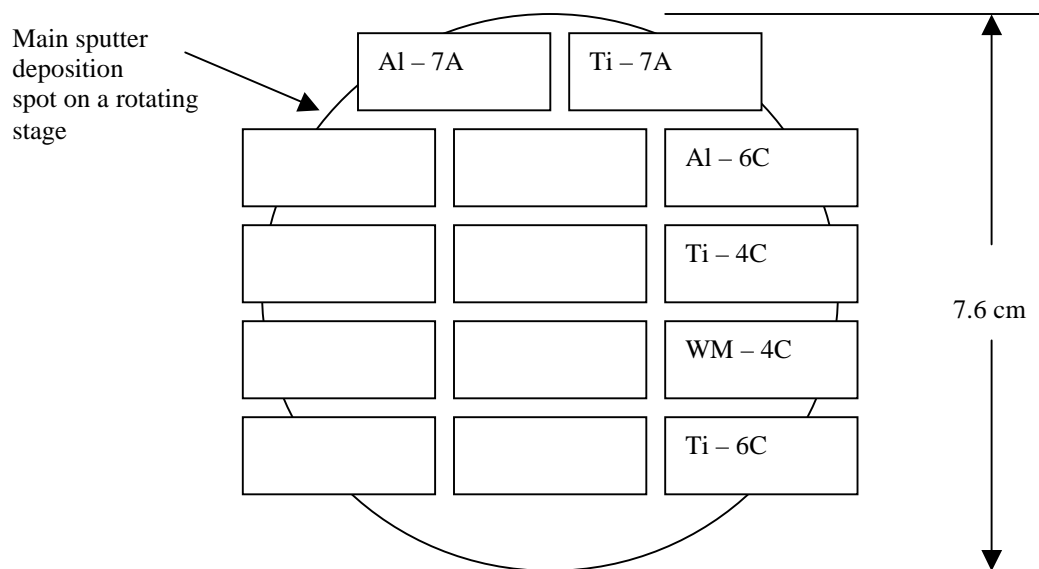
Figure 3 – Layout of coupons on the RF sputtering system stage.

The RF sputtering system used a 7.6 cm target that was pure molybdenum. The layout of the coupon substrates is shown in Figure 3. The sputter-etch voltage was estimated to be 290 V. The molybdenum film was deposited for 7 h using 1 kW RF power at an argon pressure of 1.3 Pa. The base pressure of the sputter facility without argon gas load was 4×10^{-5} Pa. Prior to the deposition process,

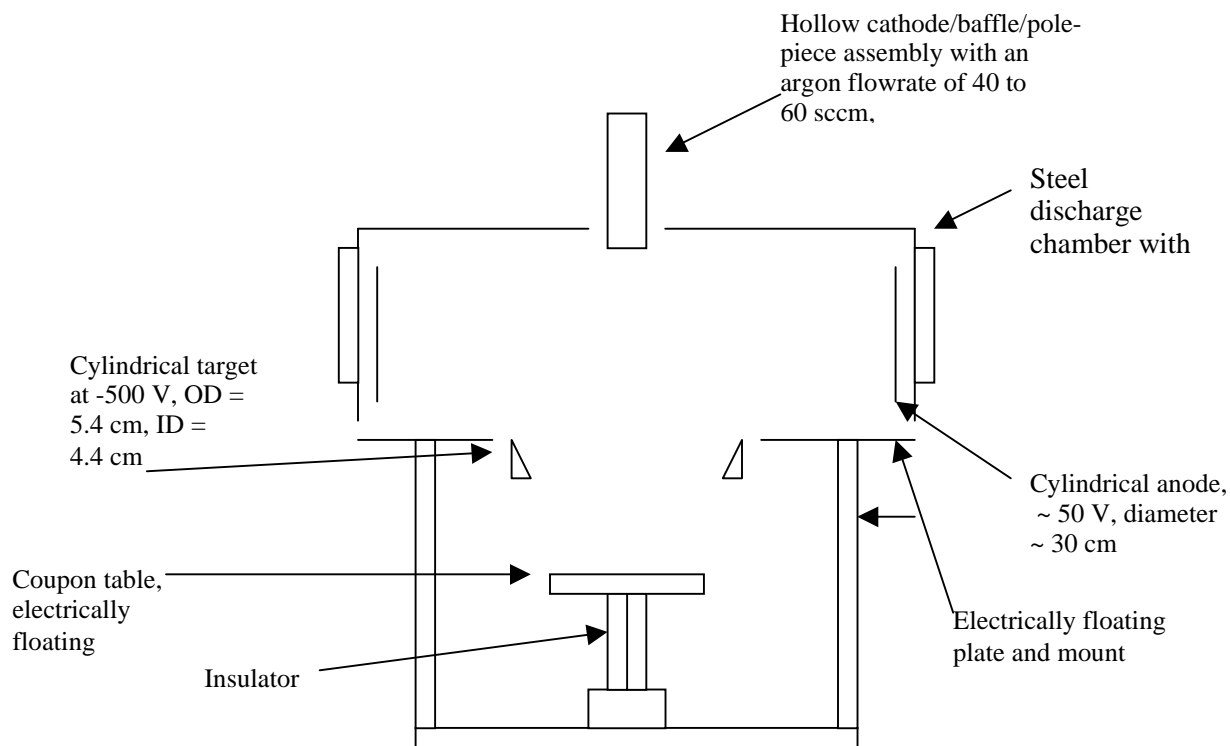
Figure 4 – DC sputtering hardware (not to scale).

The DC sputtering system is shown schematically in Figure 4. The plasma generator is nearly identical to that used for early 30-cm diameter ion engines and inert gas ion sources [11,12]. The argon discharge was generally operated at 45 V to 50 V at current levels from 6 A to 12 A. The cylindrical target was stationed near the exit plane of the discharge chamber. The coupon table was usually separated from the molybdenum target by 1.8 cm. All insulators that electrically isolated electrodes were protected from the sputtered efflux by sputter shield cups.

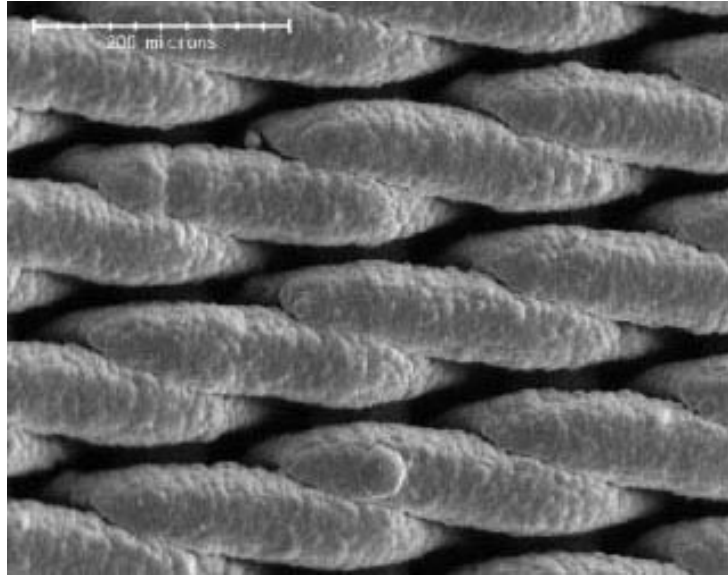
Figure 5 – Photomicrograph of the wire mesh with a 25 µm thick molybdenum coating.
The wire diameter is 51 µm prior to coating.

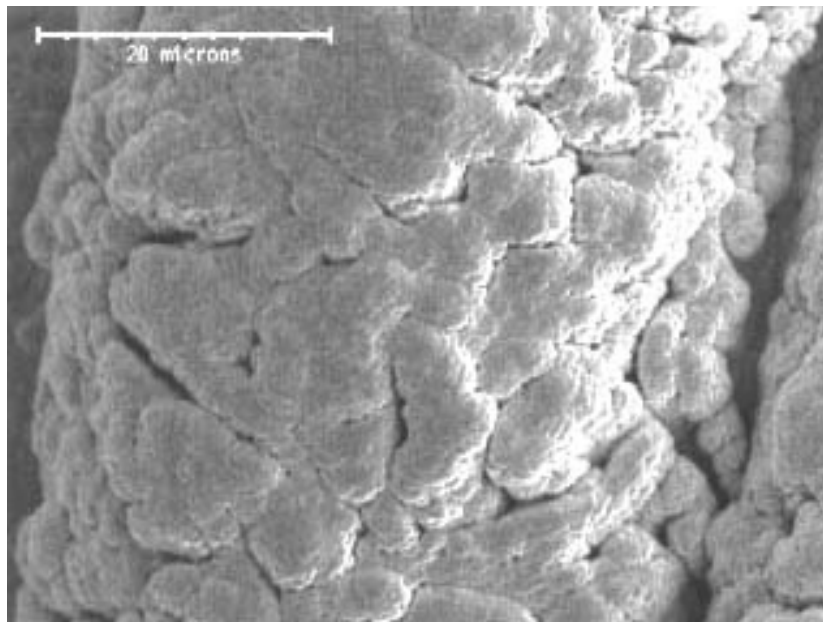
Figure 6 – Photomicrograph of a 51 µm wire contained in the wire mesh with an
8 µm coating of molybdenum.

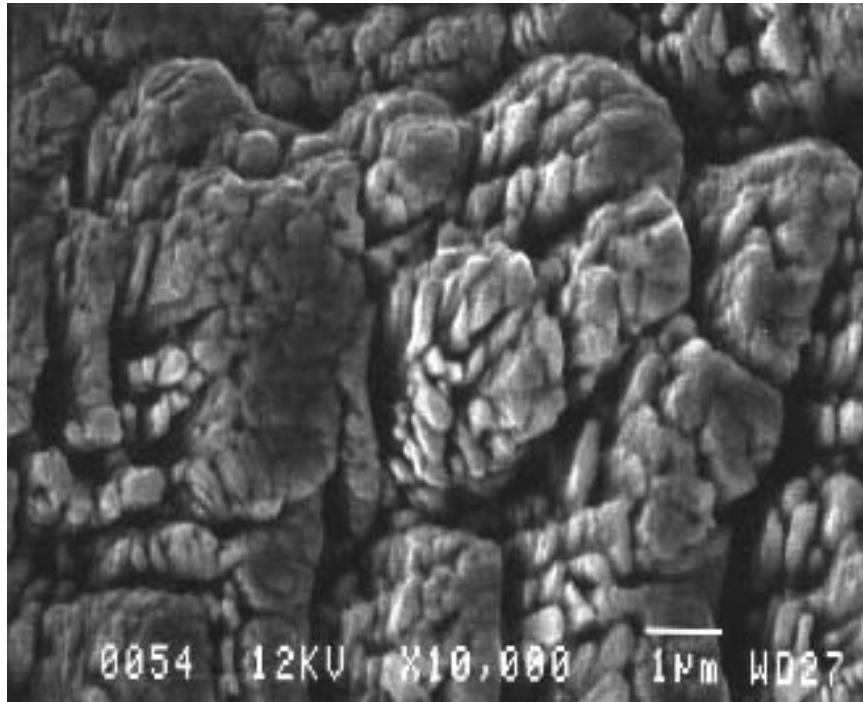
Figure 7 – Photomicrograph of a 51 μm wire surface with a 58 μm thick coating of molybdenum.

Figure 7 shows the structure of a 58 μm molybdenum coating. Large columns with 1 μm to 3 μm dimensions are comprised of many smaller columns with submicron dimensions. Molybdenum coatings with densely-packed, fiber-like columns having submicron dimensions have been reported by others using magnetron sputter deposition methods.[17] In this reference it was found that “the overall formation of the column microstructure begins at the scale of tens of microns, though the formation of a small number of cone-like structures is already observed for the 23 nm thick film.” Since the coatings applied to the wire mesh are not continuous, stresses are probably more readily relieved because of the discontinuous columnar structure.
